(RESEARCH ARTICLE)

## Experimental investigation of insulation resistance for turbo generator digital protection

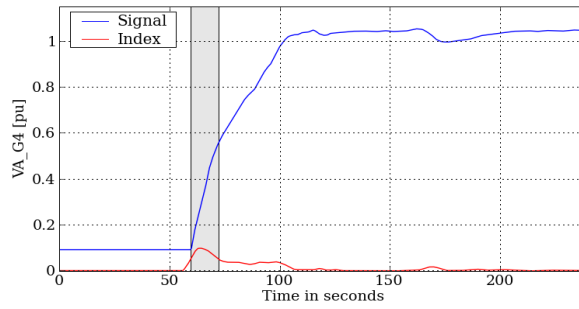
**Figure 1** Segmented Phasor Graph

The results reveal IR test is very effective in detecting ground faults in turbo generators. These values indicate leakage as a result of insulation breakdown, hence segments 1 and 2 were merged and meggering carried out with result presented in figure1.

Intelligent protection is required to instantly detect ground faults in MGs with high-impedance grounding. Ground fault protection could be done by using neutral overvoltage relays. Oscillography record system using phasor data analysis module (PDAM) from DFR was employed to map out the sequence of events (SOE) for delays. The result of the feature extracted data was used to plot the segmented phasor graph shown below in figure 1.

Pre-Diagnostic Expert System (PDES) results in energization as each phase was fired and the mean voltage signal before disturbance is < 0.1 pu and after > 0.9 pu. In figure 1 the current remains near zero. The delay of time does not express any fault or abnormal situation, delay load rejection, faults, or overload. During the execution of the No-Fault Expert System (NFES) the rule Normal Operation was fired because there was no relevant protection or circuit breaker operation within the sequence of events (SOE) list during the oscillography time interval. Thus, the final diagnosis is normal operation as the voltage sequence of RMS values gradually increased to its nominal value (1 pu) and the current, in this case, remains near zero. Special cases representing unusual generator protection configuration can be specified by the NFES. Finally, the system can identify common faults where the oscillography data can be automatically archived.

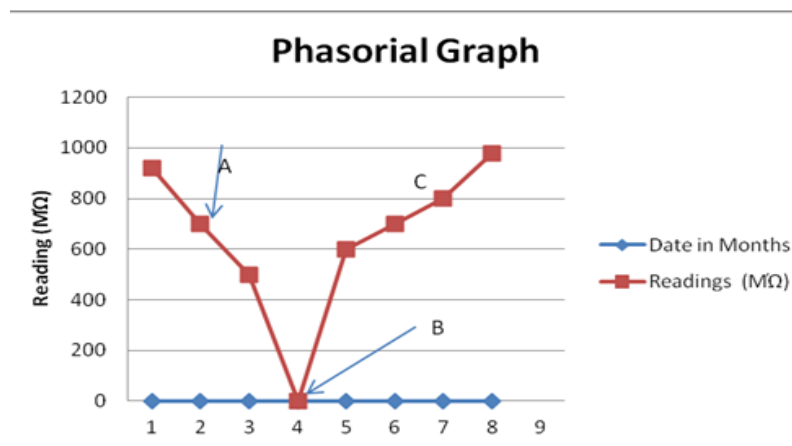
**Figure 2** Insulation Resistance Phasor Variation Graph

In table 4, tests 1 result also show that the resistance measured in 15 seconds and 60 seconds was fractional 0.4mΩ for R- YBG connection, and the phase of stator winding was just 1.0 PI. Polarization Index (PI) is a measure of quantitative appraisal of the condition of insulation for moisture and dust contamination. Sports Reading test result where a mega ohmmeter was connected across the insulation of the windings gives a test voltage applied for a fixed period of 60 seconds at winding temperature of 20 °C was used to plot insulation resistance variation curve shown in figure 2.

- A- The curve showing a downward trend indicates a loss of IR (insulation deterioration) due to conditions such as moisture, dust, dirt, or oil accumulation.
- B- A sharp drop indicates insulation failure.
- C- A continual increase in IR value after the maintenance test shows good insulation.

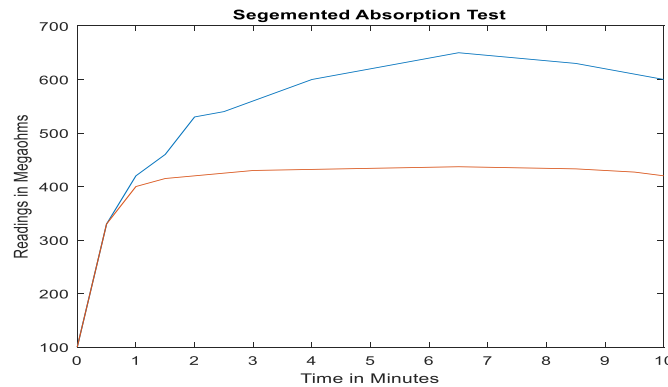
**Figure 3** Segmented Absorption Test Graph

Successive readings at specific times (60 seconds) were taken and used to plot a graph. Figure 3 gives a clear picture of the 60 seconds test for good or bad insulation. The series of tests with high operating voltage reveals insulation damage or good insulation was used to plot the segmented absorption test curve.

- i. Curve D shows insulation with excellent polarization index  $PI > 2.0$ . Insulation is thoroughly dry, clean and without physical damage thus it provides increasing resistance values despite changes in test voltage levels.
- ii. Curve E shows a substantial potential decrease when tested at higher voltage levels. This serves as a warning that the insulation quality may be deteriorating due to dirt, moisture, cracking, excessive heat, or aging.
