Structural Soundness of Carpio Hall and Federizo Hall: Inputs for planning and renovation of buildings in Bulacan State University

Global Journal of Engineering and Technology Advances, 2021, 08(03), 087–100

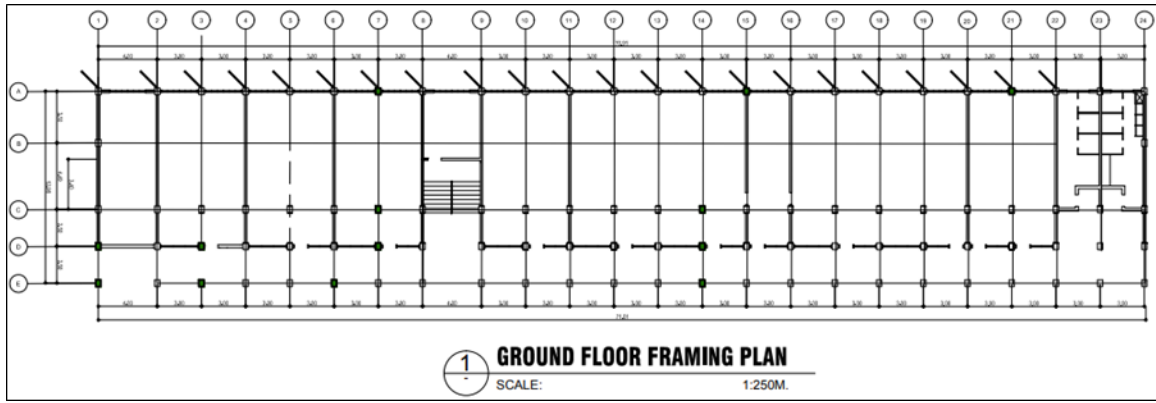
Figure 1 Color coded analysis report of Non – destructive test of Carpio Hall Ground Floor

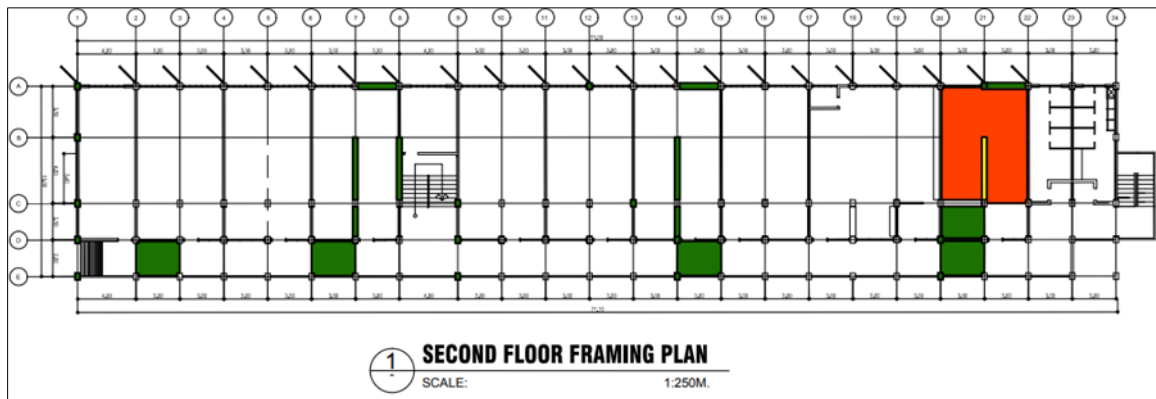
Figure 2 Color coded analysis report of Non – destructive test of Carpio Hall Second Floor

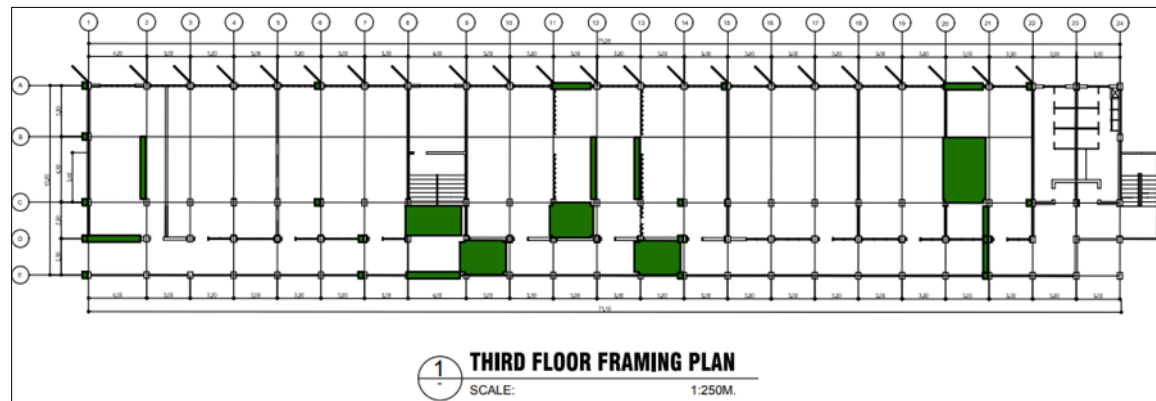
Figure 3 Color coded analysis report of Non – destructive test of Carpio Hall Third Floor

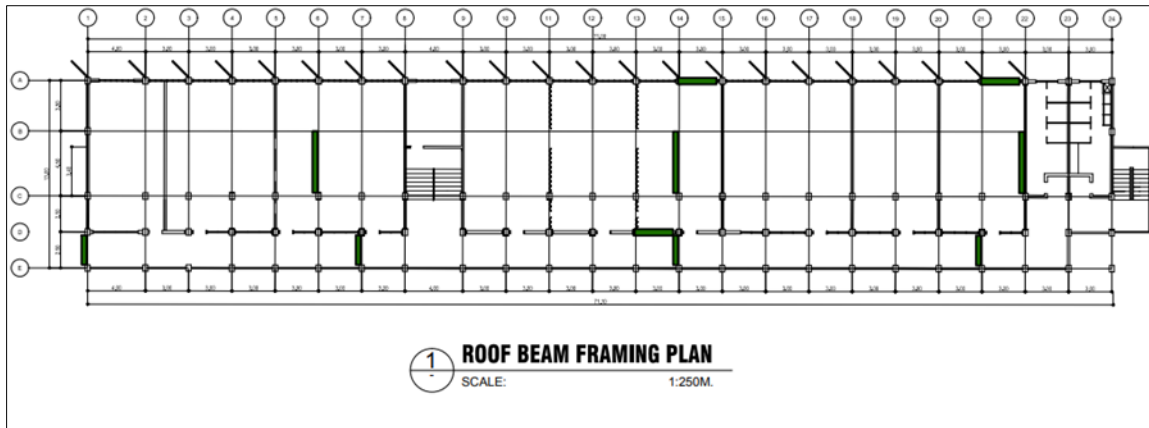
Figure 4 Color coded analysis report of Non – destructive test of Carpio Hall Roof Framing

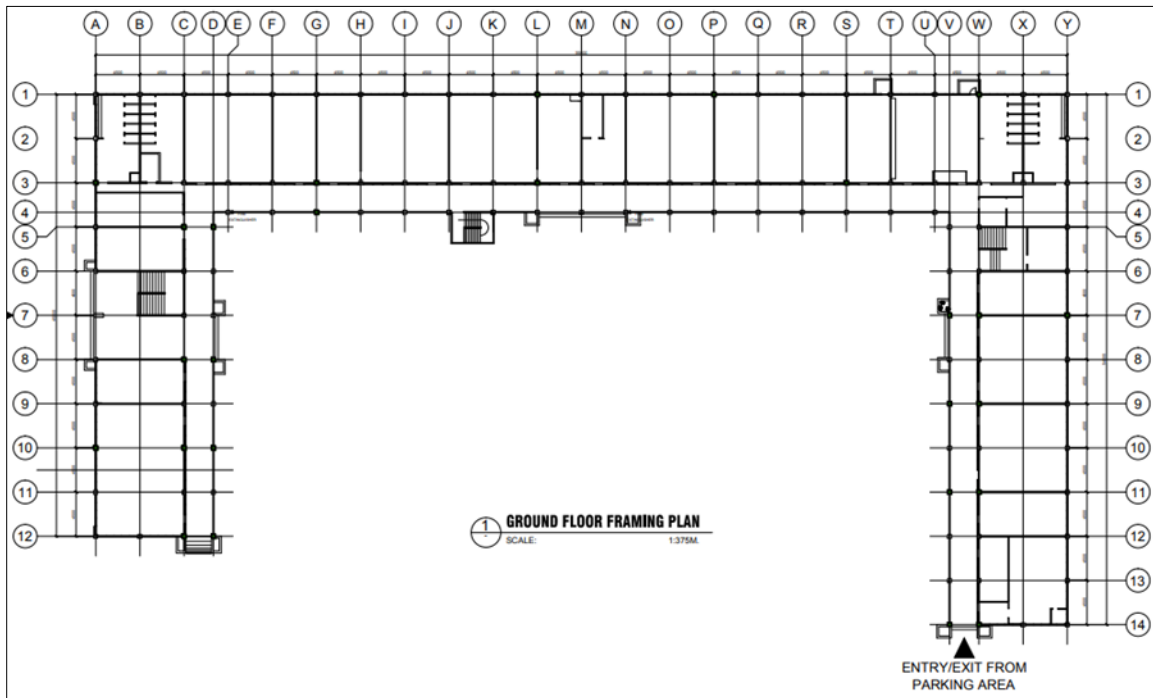
Figure 5 Color coded analysis report of Non – destructive test of Federizo Hall Ground Floor

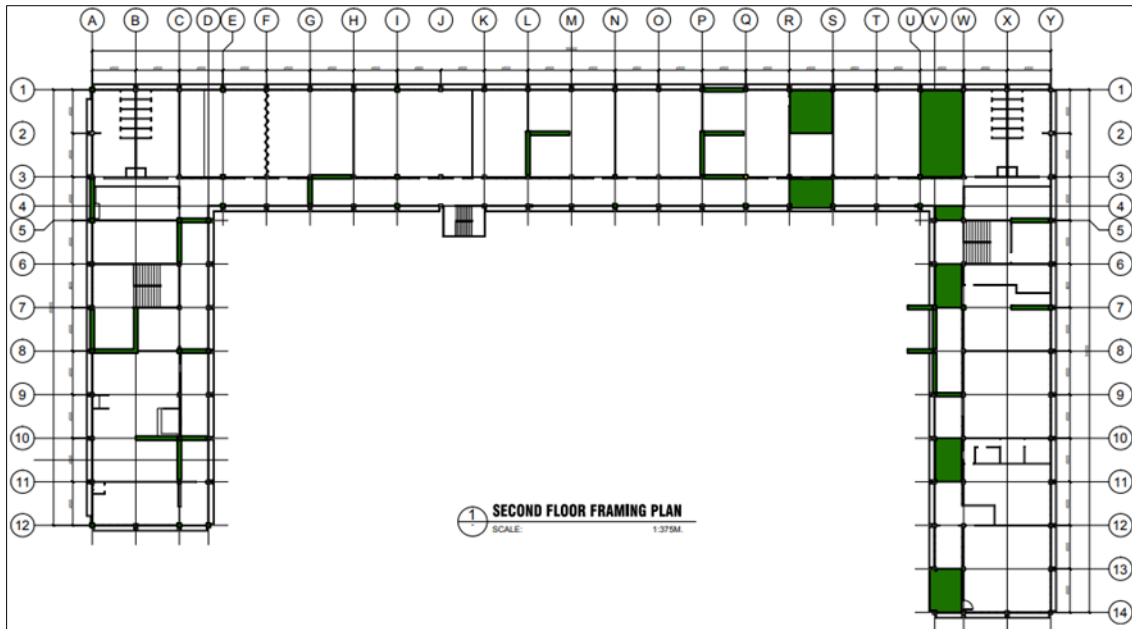
Figure 6 Color coded analysis report of Non – destructive test of Federizo Hall Second Floor

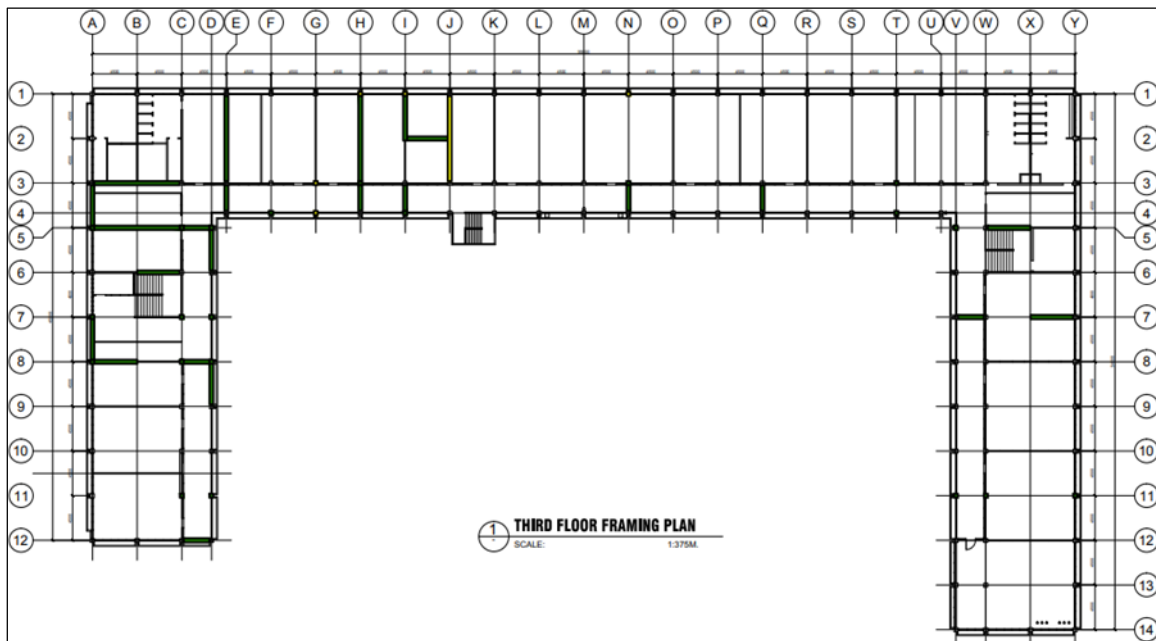
Figure 7 Color coded analysis report of Non – destructive test of Federizo Hall Third Floor

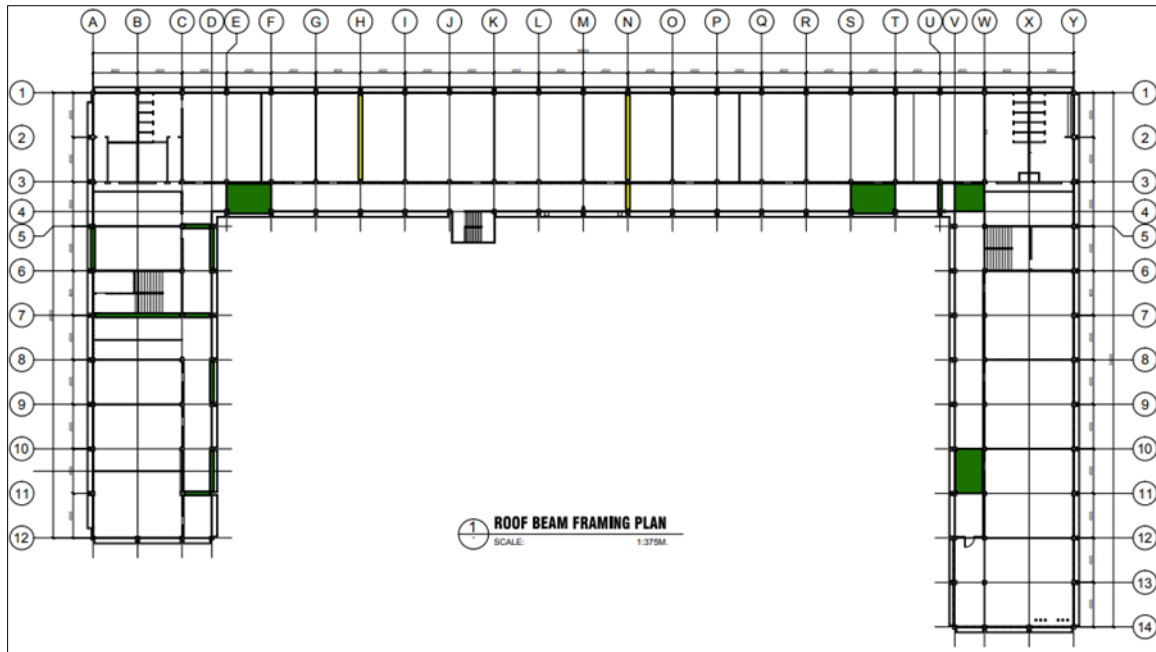
Figure 8 Color coded analysis report of Non – destructive test of Federizo Hall Roof Framing
