Bamboo and palm leaves as sustainable alternative to steel reinforcement in concrete beams

Global Journal of Engineering and Technology Advances, 2024, 20(01), 018–023

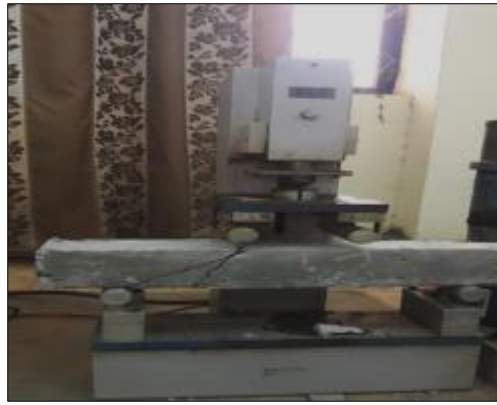
- For reference beam (B01): maximum load at collapse obtained from flexural test was 23.01 kN, which is 65% more than the design load, 8.8 kN, and 30% more than the calculated collapse load, 16.3 kN.
- The reference beam failed with a shear collapse shown by a crack at an angle of 45 degrees, as shown in Figure 1.

Figure 1 Failure Mode of Reference Beam

From the flexural test results, it was noted that the collapse load increases with the increase in diameter of the bamboo, which indicates an improvement in strength with bigger diameter of the reinforcing sample (Figure 4). The collapse mode of bamboo-reinforced beams, with a crackdown in the middle, indicates that the specimens are weak in bending and the maximum resistance to bending has not yet reached, while in the reference beam a shear collapse occurred.

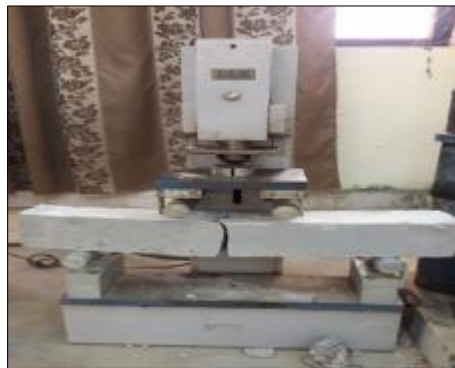
The mode of failure of these beams was a vertical crack in the middle of the beam. The crack appeared at the bottom and the width of the crack increased with continuous loading until collapse, as shown in Figure 2.

Figure 2 Failure Mode of Palm Leaves-Reinforced Beam

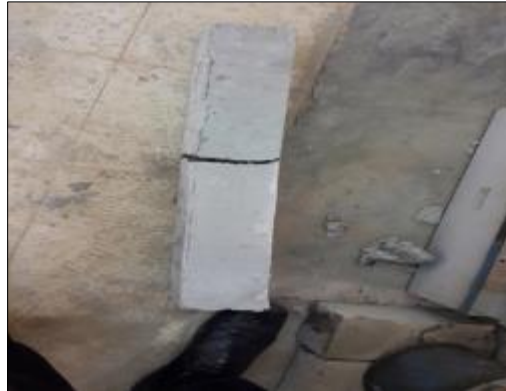
The mode of failure was a vertical crack in the middle of the beam. The crack initiated at the bottom of the beam and increased in width with time until collapse as shown in Figure 3.

Figure 3 Failure Mode of Bamboo Reinforced Beam

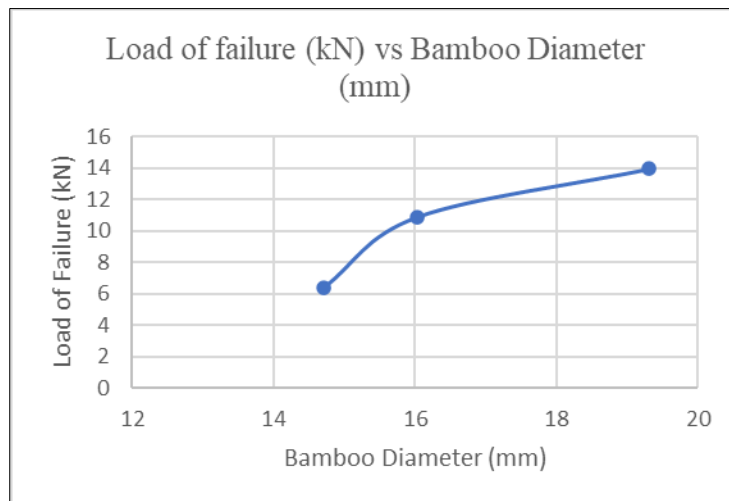
Figure 4 Relation Between Bamboo Diameter and Load of Failure

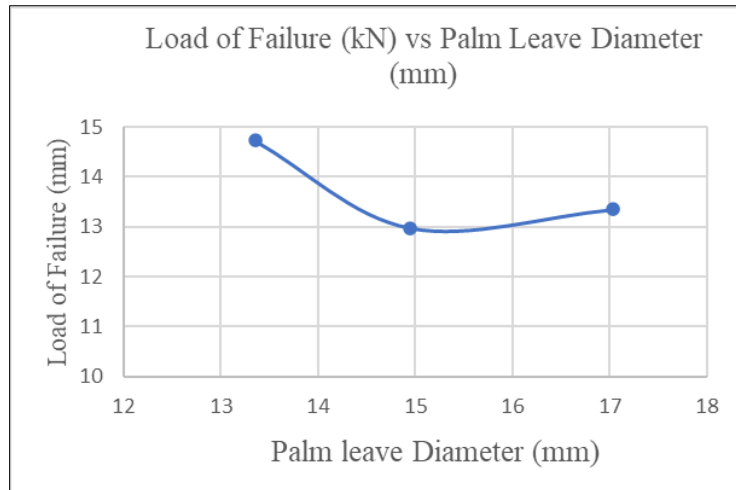
As shown in figure 5, the smaller diameter of palm leaves resulted in beam specimens with higher flexural strength.

Figure 5 Relation Between Palm Leave Diameter and Load of Failure
