## Field implementation and technical evaluation of hot tapping on active gas pipelines

Global Journal of Engineering and Technology Advances, 2025, 25(03), 091-097

Hot tapping has become an essential technique for pipeline modification in situations where shutdown is impractical or economically undesirable. This study presents a comprehensive field evaluation of a hot tapping operation performed on an active API 5L Grade B natural gas pipeline within a regional distribution network. The objective was to document the technical execution, assess weld quality through non-destructive testing (NDT), evaluate pneumatic leak testing, and analyze the performance of the drilling process, including coupon retrieval. A split tee and trunnion-mounted ball valve assembly were installed following controlled welding procedures, and weld integrity was verified using PT, MPI, and UT examinations, all of which indicated defect-free joints. Pneumatic testing using staged nitrogen pressurization confirmed full sealing performance without pressure loss or leakage indications. The hot tapping machine operated smoothly, producing a cleanly cut coupon successfully retrieved by the safety wire. The oper

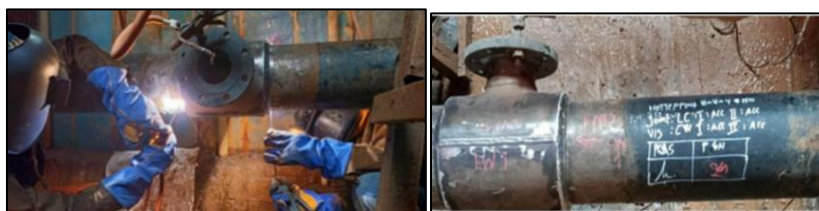
**Figure 2** Split Tee Welding Process and Post-Weld Visual Inspection

Field observations showed that all welds on the split tee both longitudinal and circumferential were completed following the specified welding sequence (root, hot, filler, and capping passes). Visual inspection confirmed uniform bead appearance and acceptable reinforcement. Subsequent non-destructive testing validated these observations. The PT examination revealed no surface cracks or porosity on the completed welds. MPI testing also indicated the absence of subsurface discontinuities, particularly in high-stress zones such as the toe of the weld and root area. In addition, UT scanning confirmed that internal bonding was free of lack-of-fusion defects and exhibited adequate penetration, meeting the acceptance criteria for hot tap fittings.

Figure 2 show two key stages in the installation of the split tee during the hot tapping process. The right-side image captures the circumferential welding performed to secure the split tee onto the live pipeline. The left-side image shows the completed weld with visual inspection markings, indicating that the joint has passed the initial assessment and is ready for subsequent NDT procedures such as PT, MPI, and UT.

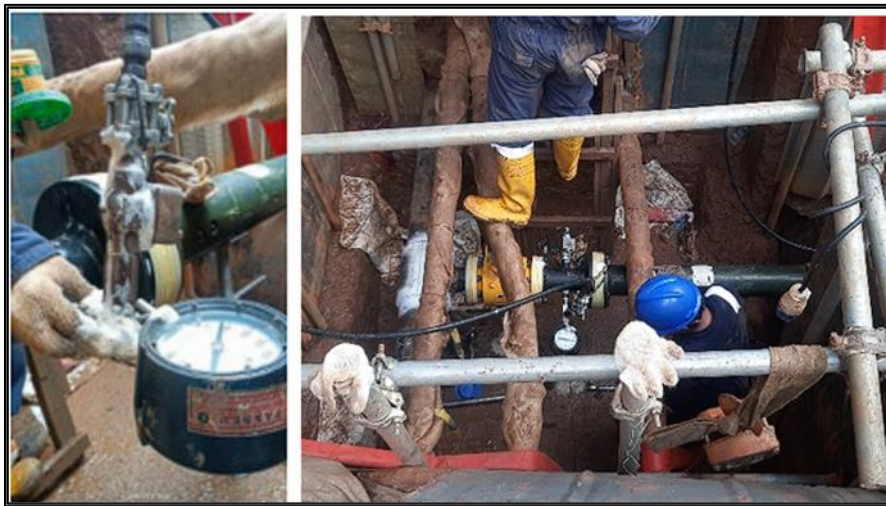
**Figure 3** Leakage test

Pneumatic testing using nitrogen gas was carried out at staged pressures of 80 psi, 200 psi, and 210 psi. Throughout the testing period, no pressure drops or bubble indications were detected at the gasket, weld joints, or valve connections. The stability of the pressure readings confirmed the sealing integrity of both the split tee and the ball valve.

Figure 3 illustrate the field execution of the pneumatic leak test conducted after welding and assembly of the split tee. The left image shows the nitrogen pressurization setup, where the gauge reading is monitored while soap solution is applied to critical joints to detect any micro-leaks. The right image provides a wider view of the test environment, showing the tapping assembly pressurized and technicians observing the gauge stability during the staged pressure hold. These visual results confirm that no bubble formation or pressure drop occurred, which is consistent with the recorded findings indicating that the split tee, gasket interfaces, and valve connections maintained full sealing integrity prior to drilling.
