## Pathological manifestations associated with hygrothermal stresses: A brief theoretical approach

Global Journal of Engineering and Technology Advances, 2026, 27(01), 204–209

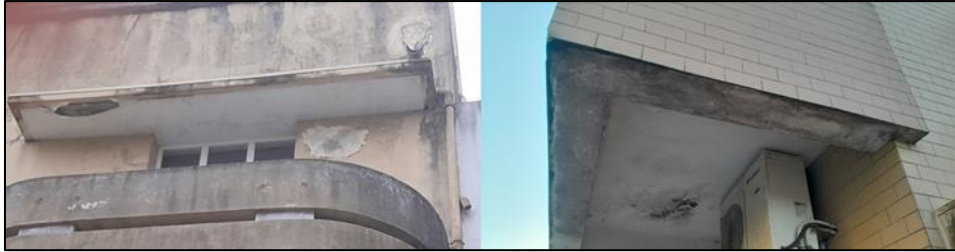
As reported by [2-3], the construction materials normally used in Brazil are hygroscopic; that is, their internal structure has pores that absorb moisture from the air. Thus, determining the origin of moisture in buildings can be considered a complex task, as it involves many aspects (transport mechanisms). Figure 1 presents two examples of pathological manifestations triggered by water-related problems in buildings.

**Figure 1** Examples of buildings with damage caused by hygrothermal stresses
