## Monitoring of structural health and safety of Flores hall and Valencia hall: Inputs for repair, renovation, and retrofitting phase II

Cecilia Angeles Geronimo \*, Radger Teddy Lee Manuel and Merricris Uson Pangilinan

Global Journal of Engineering and Technology Advances, 2023, 15(02), 073–090

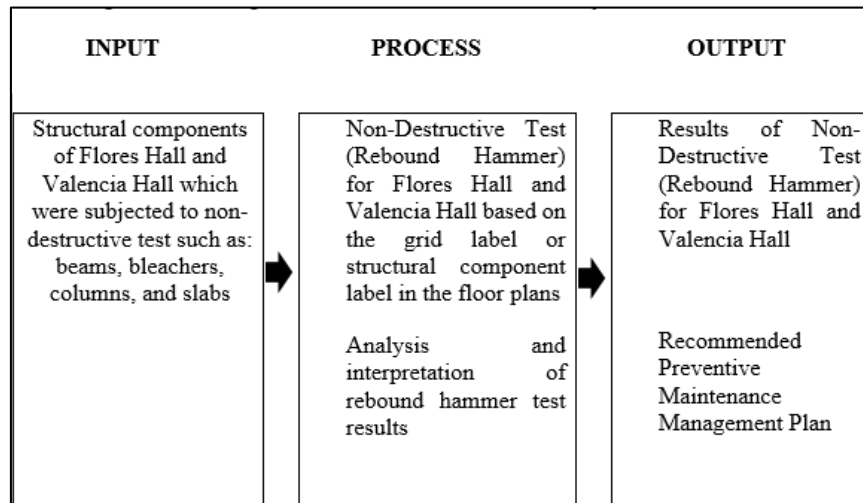
**Figure 1** The conceptual paradigm of the study

Figure 1 shows the input-process-output conceptual paradigm of the study. The Input contains the structural components which were subjected to the non-destructive test. Rebound Hammer equipment was used in conducting the non-destructive test. The following structural components were beams, bleachers, columns, and slabs of the Flores Hall and Valencia hall. The Process considered the grid label or structural component label in performing the Non-Destructive Test using the Rebound hammer equipment. After the recording in the equipment and conversion of results in the compressive strength, these data were analyzed and interpreted. The Outputs were composed of the results of the Non-Destructive Test for structural components of Flores Hall and Valencia Hall and the recommended Maintenance Management Plan.
