Level of compliance by the Bulacan State University with the fire and safety requirements of the law

Ma Victoria Villanueva Umali *

Global Journal of Engineering and Technology Advances, 2021, 08(03), 038–056

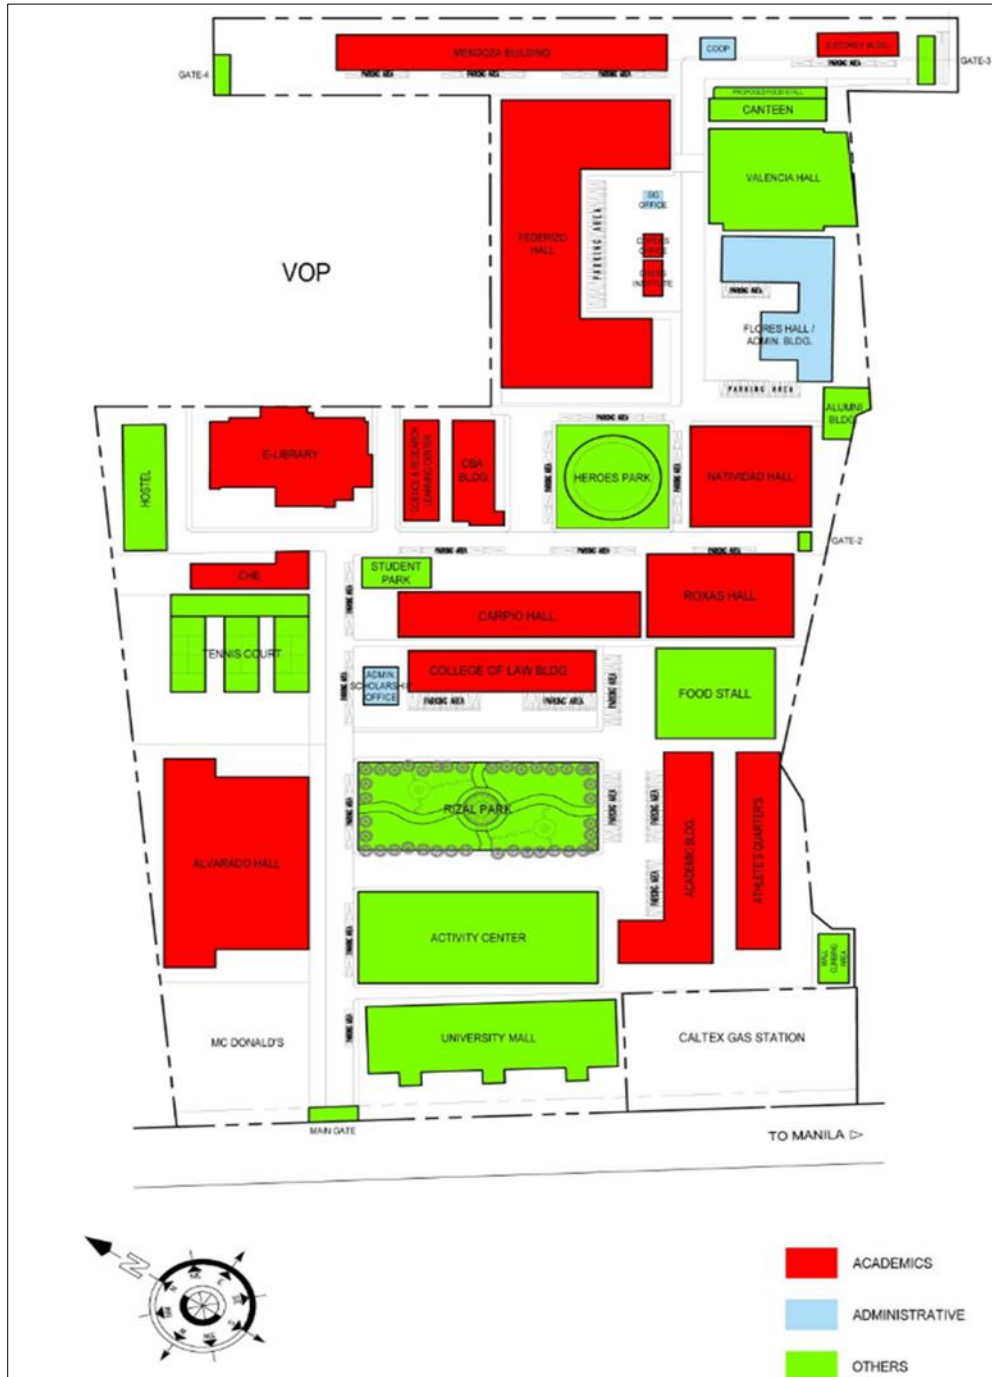
Figure 1 Site Development Plan of BulSU- Main Campus

The considerations for sampling covered only the main campus and was limited to eighteen (18) structures as shown in Figure 1, namely the Mendoza Hall (CSPS), Chocolate Building (CCJE), Federizo Hall (CS / CAL / CAFA), Valencia Hall (Gymnasium), Flores Hall (Administration Building), Alumni Building, Hostel, Science Research and Learning Center (SRLC), Natividad Hall (COE), College of Hospitality and Tourism Management Building (CHTM), Carpio Hall (Laboratory High School), Roxas Hall (COEd), Marcelo H. del Pilar Hall (COL), Alvarado Hall (CIT), Pimentel Hall

(CICT/CON), Athletes Quarter (NSTP), Activity Center (AC) and University Canteen. Thus, the satellite campuses would not be included.
